Vibration Characteristics of Industrial Gas Turbines

by Mark Dimond

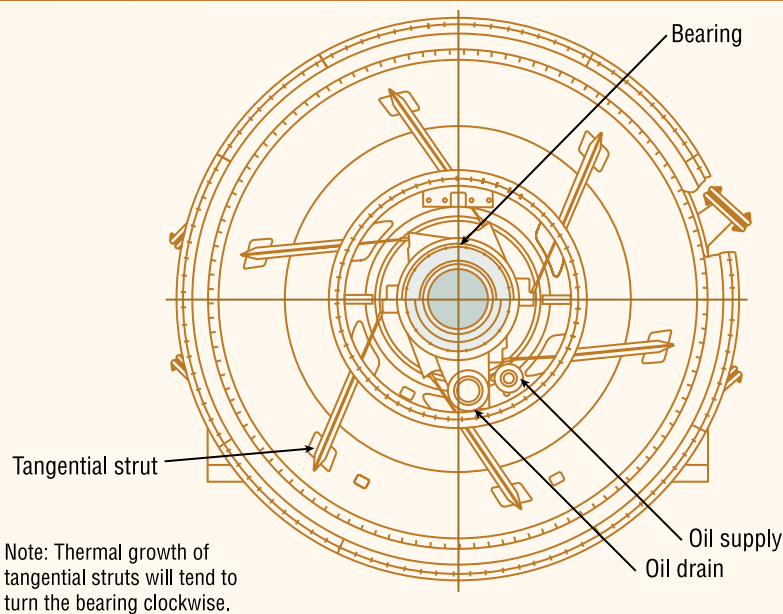
Figure 2.

As an example, Figure 2 shows a tangential bearing support for a gas turbine.

The thermal growth of the tangential supports will tend to turn the bearing clockwise (looking from the exhaust end), which is opposite the direction of rotation. This movement will distort the shaft centerline plot, at times making the shaft appear as though it is running outside of the bearing clearances. The shaft centerline plots in Figure 3 are typical shaft centerline plots from a common industrial gas turbine. These plots were compensated using startup data. Other models of gas turbines using radial and tangential bearing support structures will show similar characteristics.

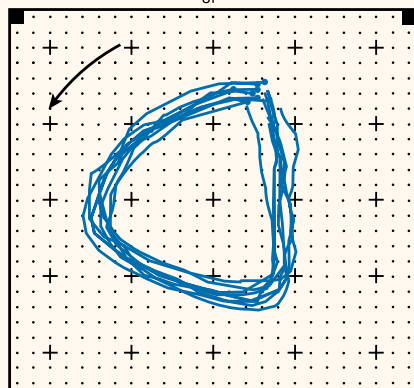
Figure 4.

Orbit plot from data taken during a previous startup (32 samples/rev)

An orbit plot, Figure 4, from data taken during the most recent startup, one month earlier, showed indications of a

rub at the exhaust-end bearing. The rub was indicated by flatness on the right-hand side of the orbit. Although it seemed unusual that a rub could last for such a long period, the vibration data together with the symptoms exhibited by the machine seemed to support the theory.

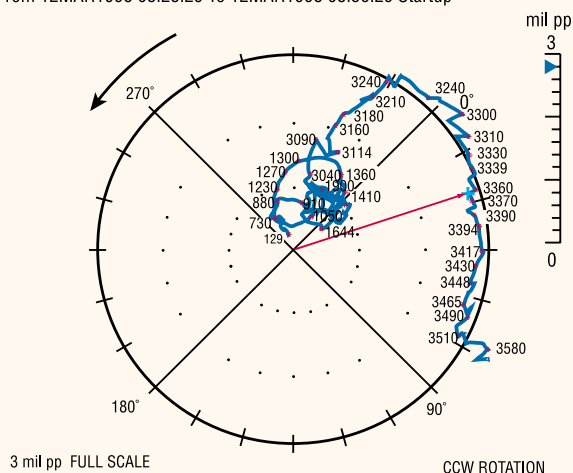
Figure 5.

plots using startup data showed that the unit passed through the first balance resonance at about 1200 rpm. The second balance resonance was expected to occur between 2600 and 2800 rpm. However, as the unit passed through this speed, none of the expected activity normally associated with a resonance occurred. At 3000 rpm, vibration increased rapidly to just above three mils peak-to-peak. At 3200 rpm, the increase in vibration suddenly stopped, and the phase changed 90° from 3200 to 3600 rpm. From this polar plot, it appeared that the second balance resonance was shifted from the 2600 to 2800 rpm range to just below running speed. Rotor-to-stator rubbing will increase direct support stiffness. An increase in stiffness will increase resonance speed. The pattern observed in Figure 5 is typical for a rub condition.

Polar plot of startup, exhaust-end bearing

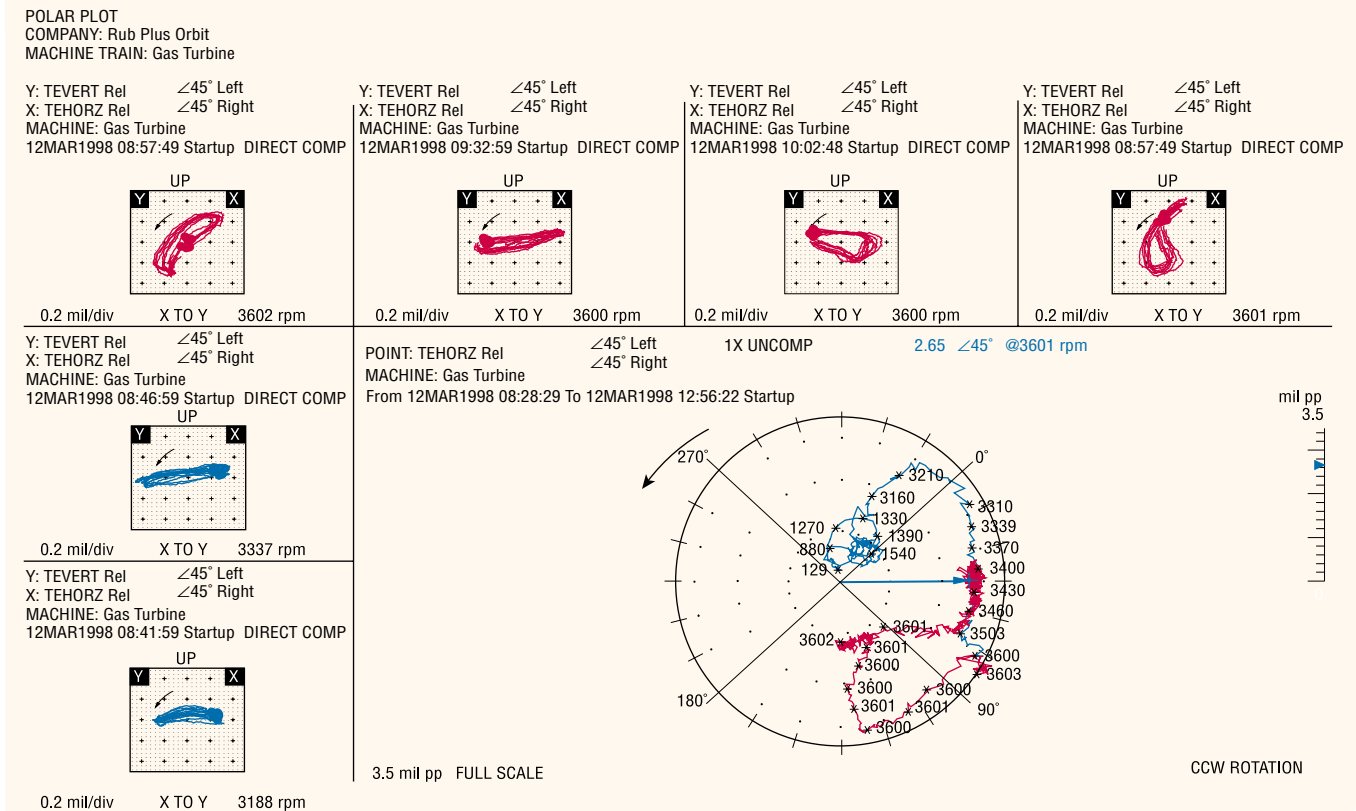
Figure 6.

Figure 6 shows the same startup polar plot with orbit plots for several different speeds. Note the flat shape of the orbit plot indicating an abnormal path of the shaft centerline. In this

Polar plot with shaft orbits at several speeds

case, the shaft appears to be heavily preloaded. As mentioned previously, a rub was suspected based on the shift in the 2nd balance resonance frequency with the unit coupled to its load. The presence of a heavy preload as evidenced by the orbit shape gave further support to a rotor-to-stator rub as the most likely malfunction.

As such, a check with the original equipment manufacturer (OEM) indicated that the clearances on turbine seals might have been reduced as a part of a recent upgrade.

collected data subsequently led to disassembly of the machine and inspection of the seals. As expected, a seal rub was confirmed. Also, heavy deposits of oil and combustion by-products were found on the turbine seals. The seals were replaced and the unit was returned to service.
